SUBJECT: Site Inspection, U. S. Energy, Velvet Mine, M/037/040, San Juan County, Utah

Date of Inspection: July 1, 2004  
Time of Inspection: About 3:00 to 3:45 p.m.  
Conditions: Mostly clear, 80's  
Participants: Paul Baker, DOGM

M/037/040, Velvet Mine, U. S. Energy

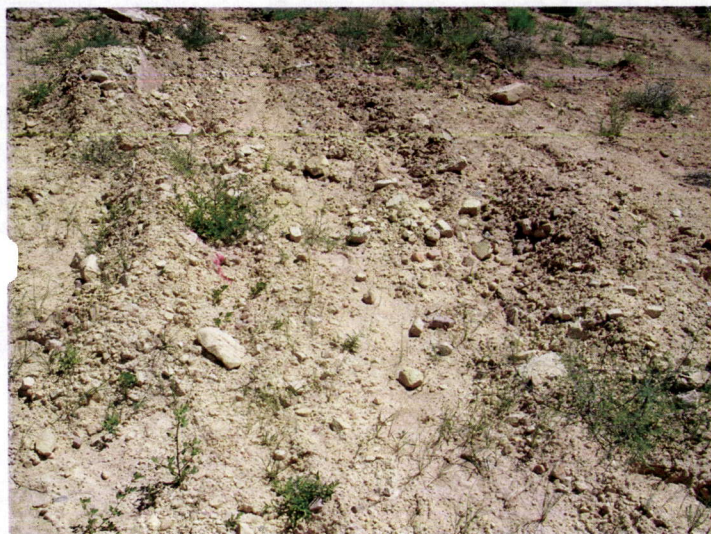
Vegetation is progressing nicely. I found numerous seedlings in nearly every part of the reclaimed area although they were more numerous and larger where topsoil was spread. Photo 1 is typical of areas where topsoil was spread, and Photo 2 shows a slope where soil was not applied. Photo 2 also shows the benefits of ripping on the contour: most of the seedlings are in the depressions created by ripping.

**Photo 1. Vegetation in an area that received soil over the waste.**

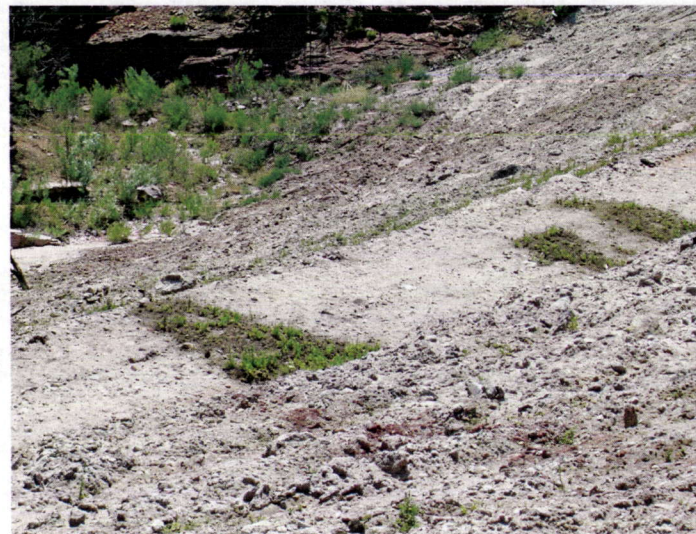
The manure was not spread real evenly at the mine site, and it's easy to tell where it was placed (Photo 3). I could not tell that there was an increase in desirable vegetation in these areas, but there were definitely more weeds. This should be checked again to see if there were beneficial effects of applying manure.

**Photo 3. One of the contour terraces where manure was spread.**

I do not recommend any remedial action at this time. The Division and the operator should continue to monitor the site, including the areas where manure was applied to see if there are long term benefits. With continued rainfall this summer (which it appears the site has received), the vegetation should become well established. There has been a little erosion, but it is minor.

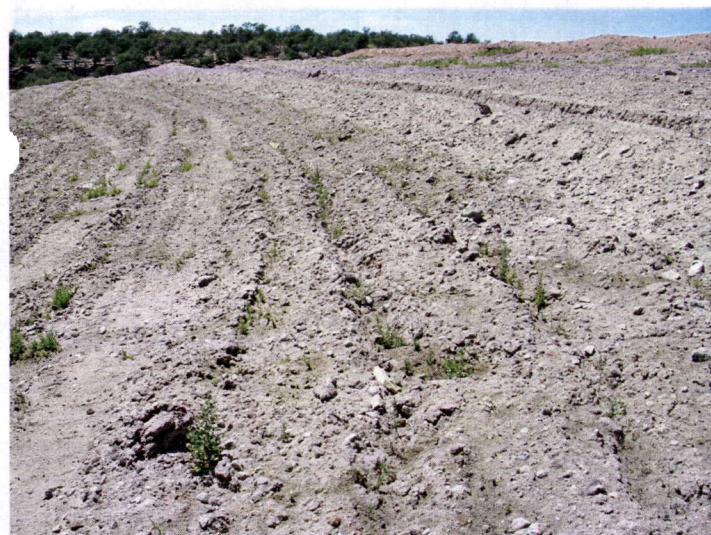
**Photo 2. A slope that did not receive topsoil. Note how most of the vegetation is in the ripper marks.**

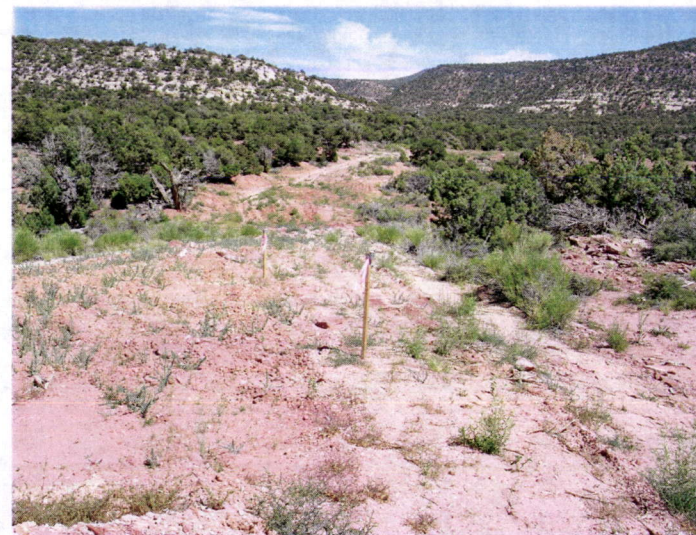
Near the entrance to the mine site, I found two claim markers. The information on a paper attached to one of the markers was:

**Photo 4. Claim markers near the entrance to the mine site.**

Because of the claim markers, the Division and operator should also look for signs of any mining or exploration activity occurring in the reclaimed area. No one has yet submitted a notice of intention for conducting these operations in the area, so this kind of activity would be in violation of the Mined Land Reclamation Act.
